Emery Grover Building

Needham Senior Center Site Feasibility Study

BH+A Project No. 2961.00

August 6, 2010

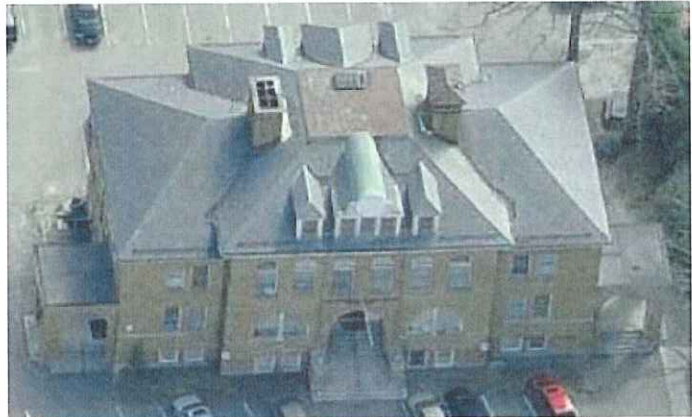
Sloped roof surfaces are slate, with copper trim.

1. Remove slate roofing and replace with new to match existing. Provide new copper flashings and valleys and snow guards. Repair deteriorated sheathing. (Assume 10% of sheathing is deteriorated, primarily at valleys.)

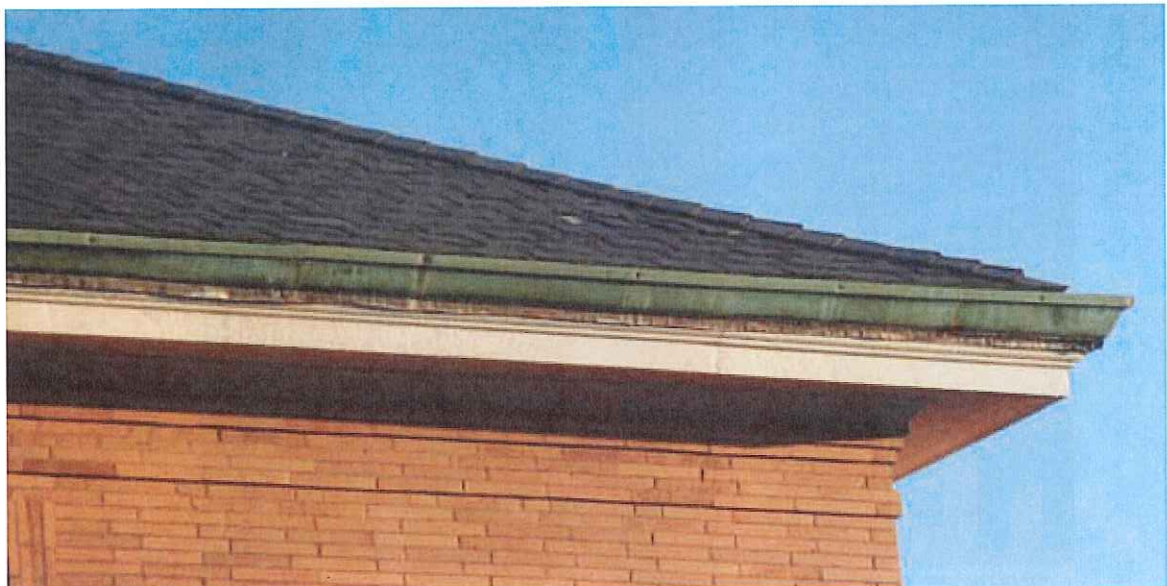
The field of slate appears to be in generally good condition, though there are leaks at transitions.

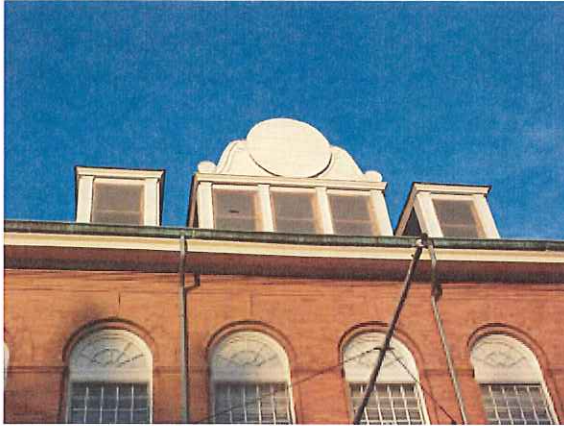
Dormers at front have plexiglass over windows and slate at sides.

2. Remove slate at dormers and provide new to match existing as closely as possible. Repair wood (or metal) at dormer faces and repaint. Remove plexiglass. Remove window sash and restore. Reconstruct clock face and working clock parts. (It is not known how much of the original clock face remains.)

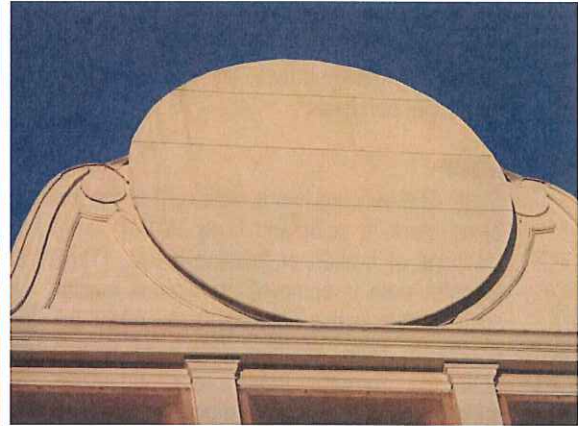
A panel has been installed at the original clock location.

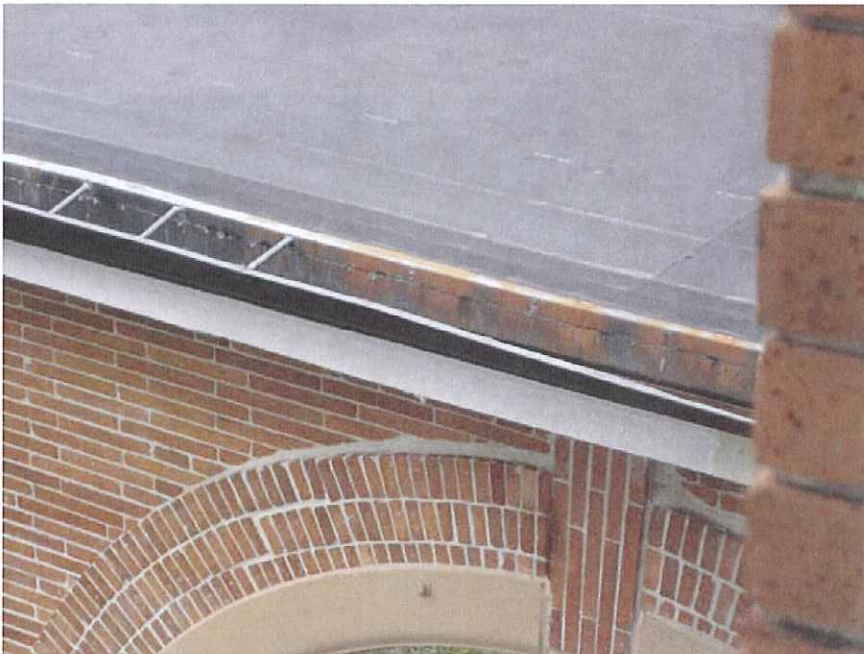
Gutters: In addition to what are likely copper valleys and flashings, the building has external copper gutters at the upper roof edge and at the north and south porticos. While the upper gutters cannot be seen well from below, the portico gutters can be seen from the interior of the building and are visibly bent in areas, with several of the straps that hold the gutters in place missing. There are areas of wear to the copper that look to be very severe, where the material has worn through and now is a bright orange color.

Copper gutters are worn and in need of repair.

3. Remove copper gutters and replace in kind.
4. Retain original metal soffit components and repaint. Remove patch areas and provide new metal with profile to match the original.

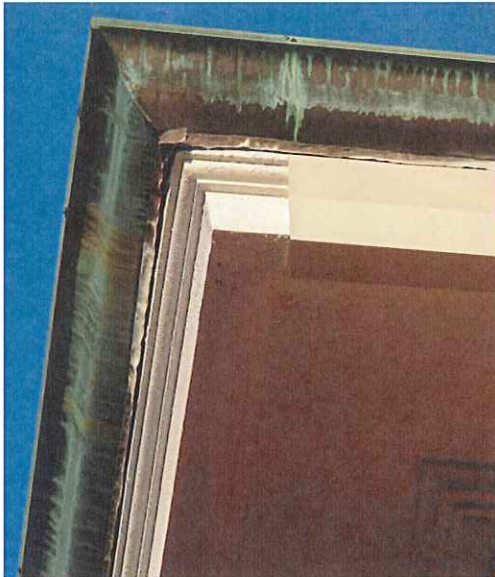
Soffit: Just under the copper gutters is a white painted soffit. A detailed view of this shows the material is ribbed in texture, which is an indication that it is metal. At many locations the vertical face of this, the fascia, has been covered over with another piece of metal as a patch to what likely had been deterioration due to leaking at the gutters. The patch material looks to be a prefinished galvanized metal and does not match the profile of the original.

A patch has been added at soffit areas where metal must have been damaged

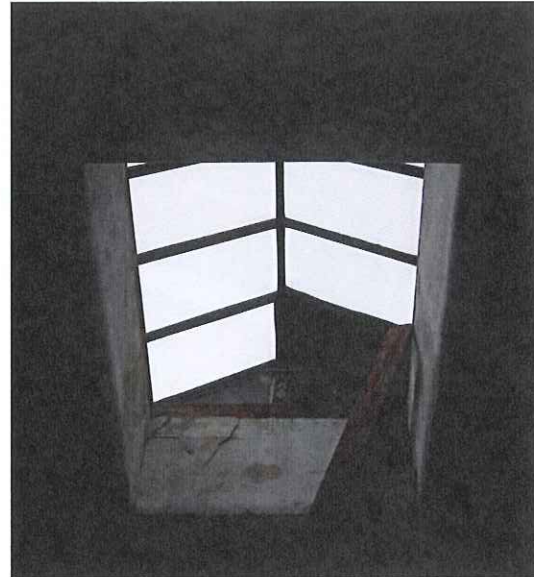
A skylight at the attic level is in need of repair

Skylight: There is a skylight at the attic level that appears to be original. Its glazing is wire glass, and at least one lite is missing. Wire glass does not comply with current codes for safety. At the exterior the skylight is set in an area of flat metal roofing of questionable condition. (An early photograph of the building shows there was once a balustrade at this location.)

5. Remove skylight, infill, and provide new metal flat seam roofing. Include an Alternate cost for reconstructing the balustrade that is visible in the early photograph. Assume painted wood for the balustrade and additional structural support..

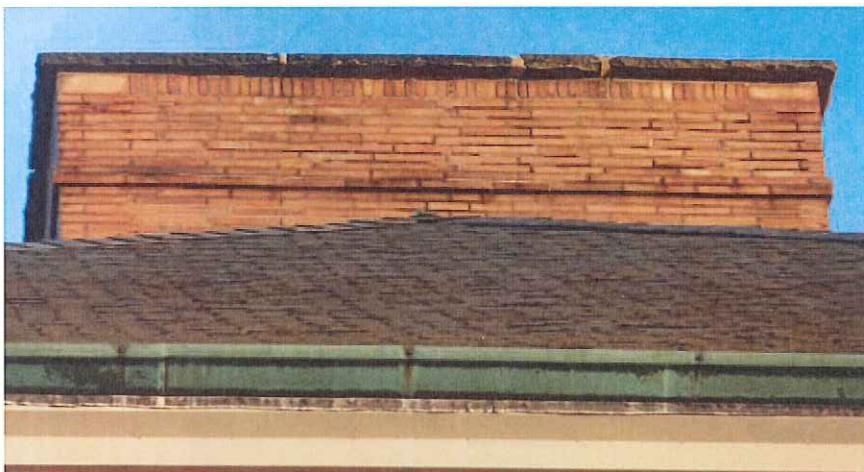
Chimneys: The two brick vent shafts that extend above the roofline are in poor condition. The mortar is missing at most locations. Also, a metal cap and straps were added at one shaft. The other shaft is exposed at the top, and six flues are visible. The assumption is that these will retain the function of exhaust for the new building mechanical system and should have some cover to prevent rain from entering.

Brick at the two chimneys is missing mortar and requires rebuilding.

6. Disassemble brick chimneys, salvaging original bricks, and rebuild. Provide raised metal or stone caps at both locations.
7. Replace membrane roofs at porticos as part of properly detailing gutter flashings. Include an Alternate cost for reconstruct the ornamental balustrades that are visible in the early photograph. Assume painted wood for the balustrade and additional structural support.

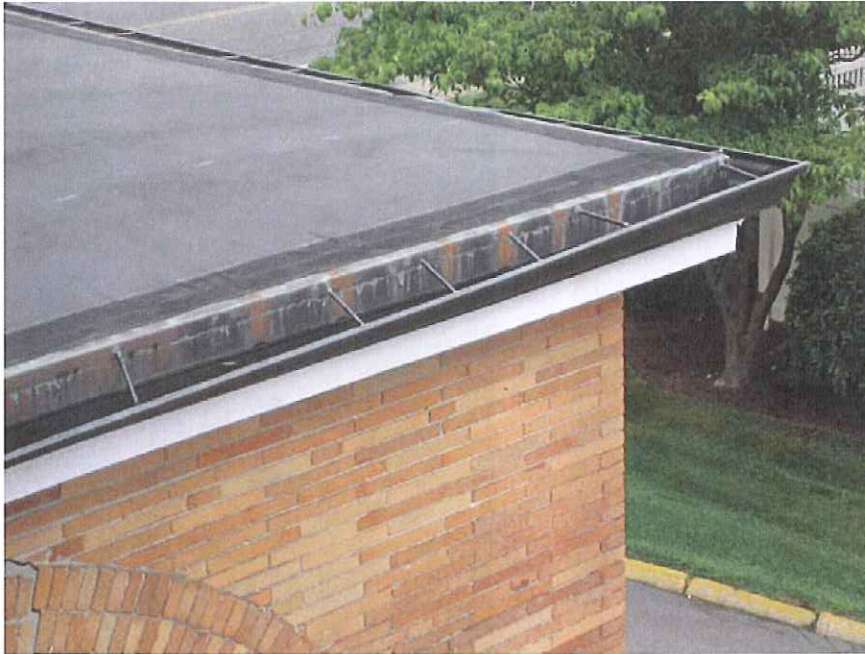
Portico Roofs: Membrane roofing at these areas appears to be fairly recent and is in good condition.

Porticos have membrane roofing that is fairly recent.

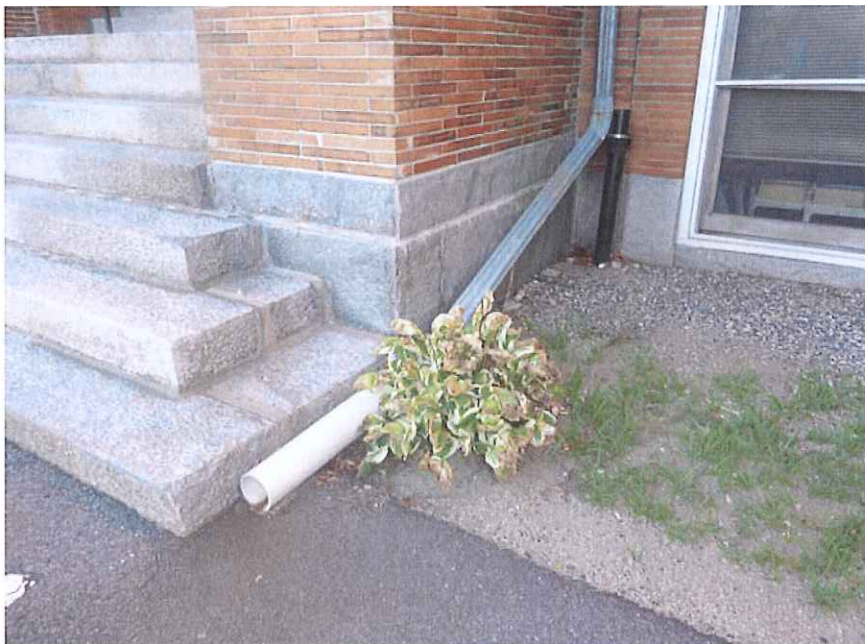
Rain leaders: Rain leaders include some copper and some aluminum. Some of these are connected to cast iron boots at the ground and are thus connected to the storm water system. Others have been diverted so that they deposit rainwater at the paving. The rainleaders at the center bay, around the front entry, were not original to the building. This is based on the early photo. It is assumed that there was also no rainleader at the center at the rear of the building either.

Rain leaders have been diverted from the storm drainage system at some locations.

8. Remove existing leaders and replace with new copper leaders, all connected to the underground storm drainage system. Slope new gutters so that original rainleader locations can be used and not the added locations there are now.

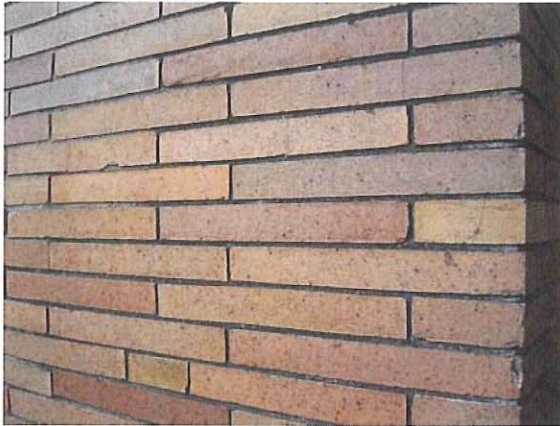
The very distinctive yellow brick is in good condition.

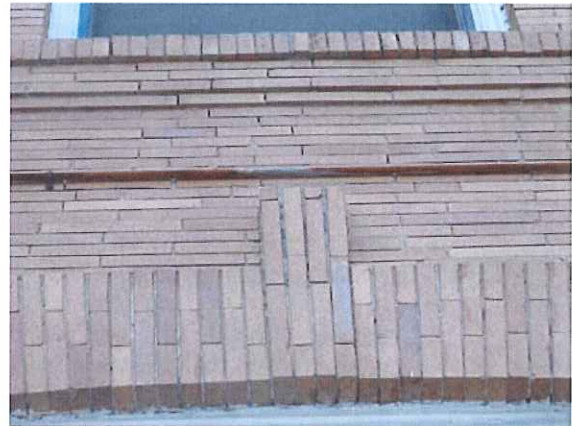
Mortar is missing at some locations, and there are areas of displaced bricks that require resetting.

1. Cut out and repoint mortar joints at areas of mortar loss. Assume repointing of 10-15% of the overall brick at the building.
2. Remove and reset loose or shifted bricks, assume added pins will be required at some.

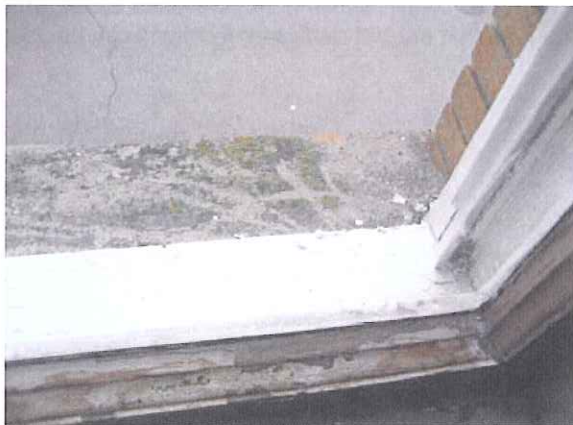
Bricks are displaced at some locations where there has been water infiltration and at some of these locations the walls are bowing. This occurs most significantly under the second floor windows of the south elevation and at the north end of the rear elevation. One cause of bowing of the bricks is that 2nd floor window sills are brick, so water has entered at joints. The sills at the 2nd floor have a cement parge over the brick.

Exterior brick sills at the 2nd floor have a concrete parge. The failure of this has allowed water into the walls.

7. Remove concrete was at 2nd floor sills and provide masonry coating.

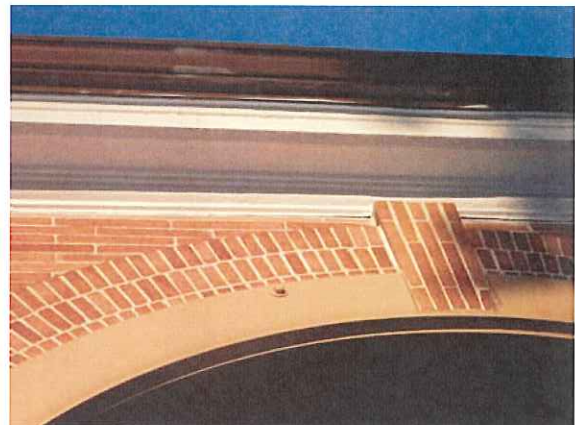
Steel reinforcing was added at the south portico arches. This should not be considered a permanent solution.

The north and south porticos have cracking and other problems, and the south portico had steel support added at some point at the arched openings. This support is visible and detracts from the appearance of the building. The understanding is that this repair was intended at the time to be a temporary fix.

6. North portico – reinforce arches with steel, similarly to that done at south portico arches, or preferably, in a way that retains the original appearance of the brick and conceals all structural support in a way that is not visible. Revise south portico arches to do the same to them, removing the existing exposed steel support.

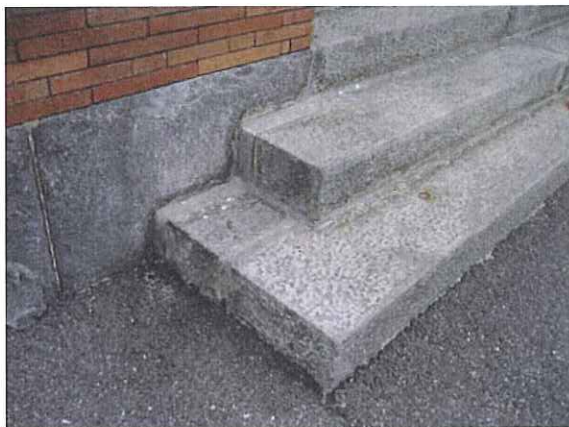
The granite steps are in good condition.

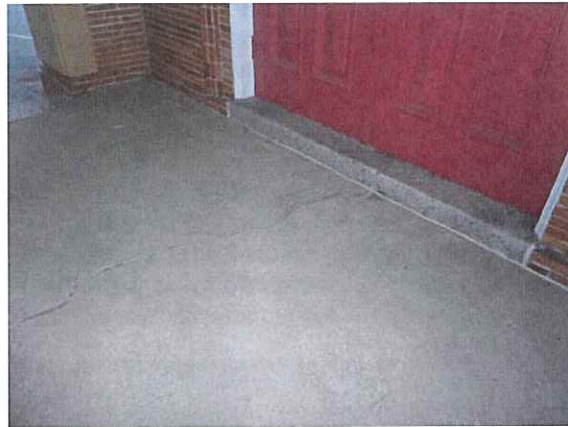
Concrete landings at the porticos have cracks but are sound.

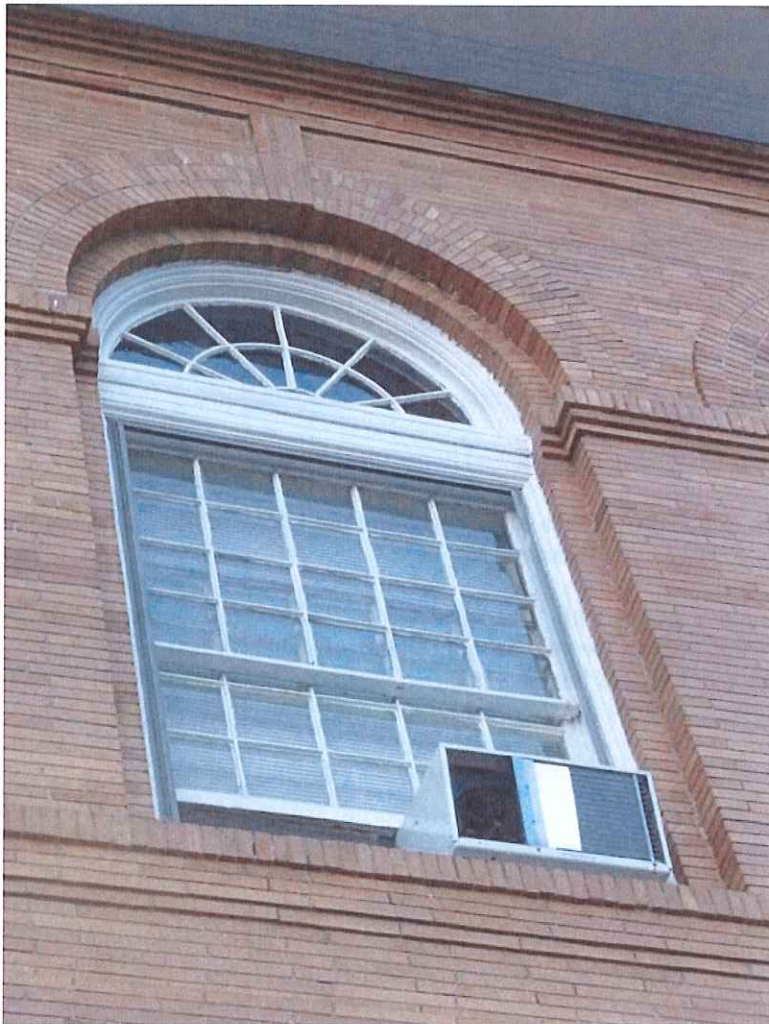
Windows are in good condition. A review of the interior conditions at several locations indicated that wood is sound. Many windows are fixed shut, or fixed partially open where window air conditioner units have been added, so operability could not be tested. Operable windows, the majority of which are double hung, have locking hardware and chain pulleys, but are missing some of the chains. Interior casings are typically intact.

Double-hung windows are in good condition, though some work is required to make them functional.

1. Remove unit air conditioners, added storm windows, added screens and the four non-original double hung windows at the rear of the 1st floor.
2. Restore existing windows by removing sash, stripping, replacing missing hardware, and repairing deteriorated wood at both sash and frames. Include removal of putty and glass at locations of mismatched glass or damaged muntins and providing new.
3. Add interior storm windows with aluminum frames at all interior locations.

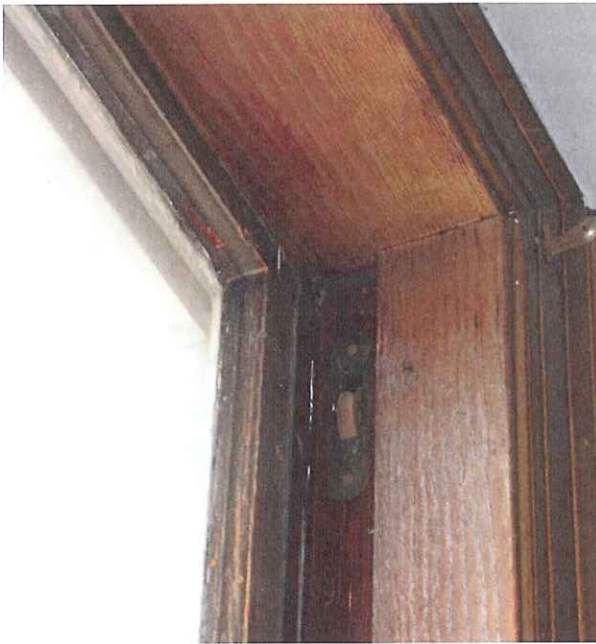
Window hardware is missing at some locations. Interior wood is sound.

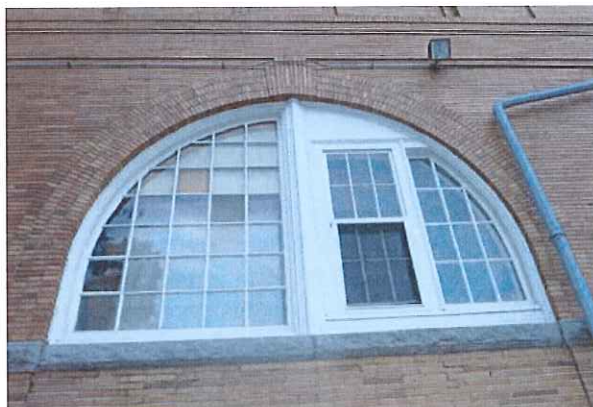
The locations with the most significant changes are the large arched windows at the 1st floor rear. Here, complete double hung windows and interior stools and trim were added inside the original arched frames, with added plywood to fill in the arched opening. The replacement windows at the basement are wood, with insulating glass. Their exterior appearance is not noticeably different from the other basement windows. At three locations original basement windows have been removed and doors added. The need for these to remain as doors will depend on the proposed renovation, though ideally the windows would be reconstructed.

Windows have been replaced at the first floor at the rear elevation. The left half is original, while a full double hung window was inserted at the right.

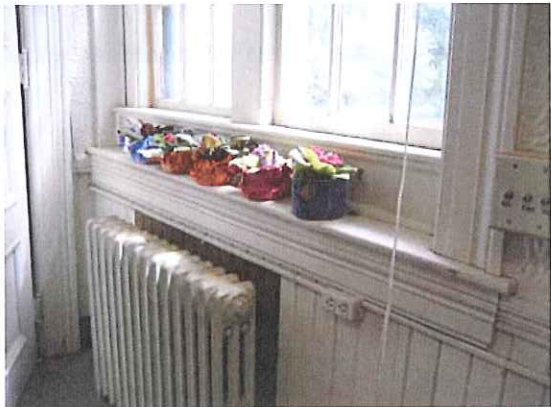
The complete new window and trim is visible at the interior, where the original trim also remains.

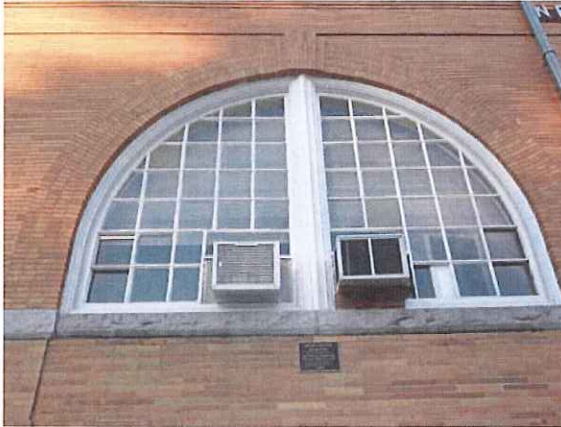
Fixed window at the front of the building is original, though modified for air conditioner.

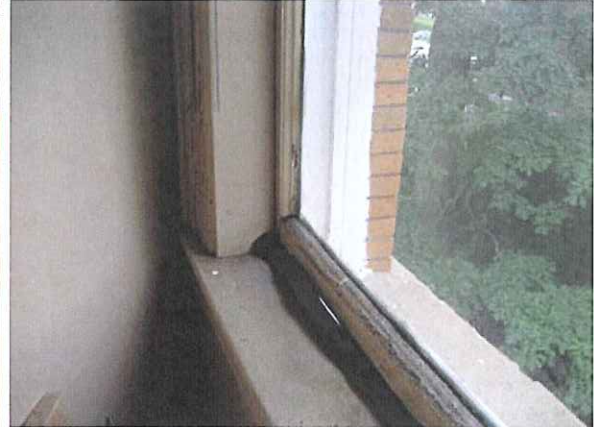
Existing single glazed windows have some problems with air infiltration. Interior storm windows could be added

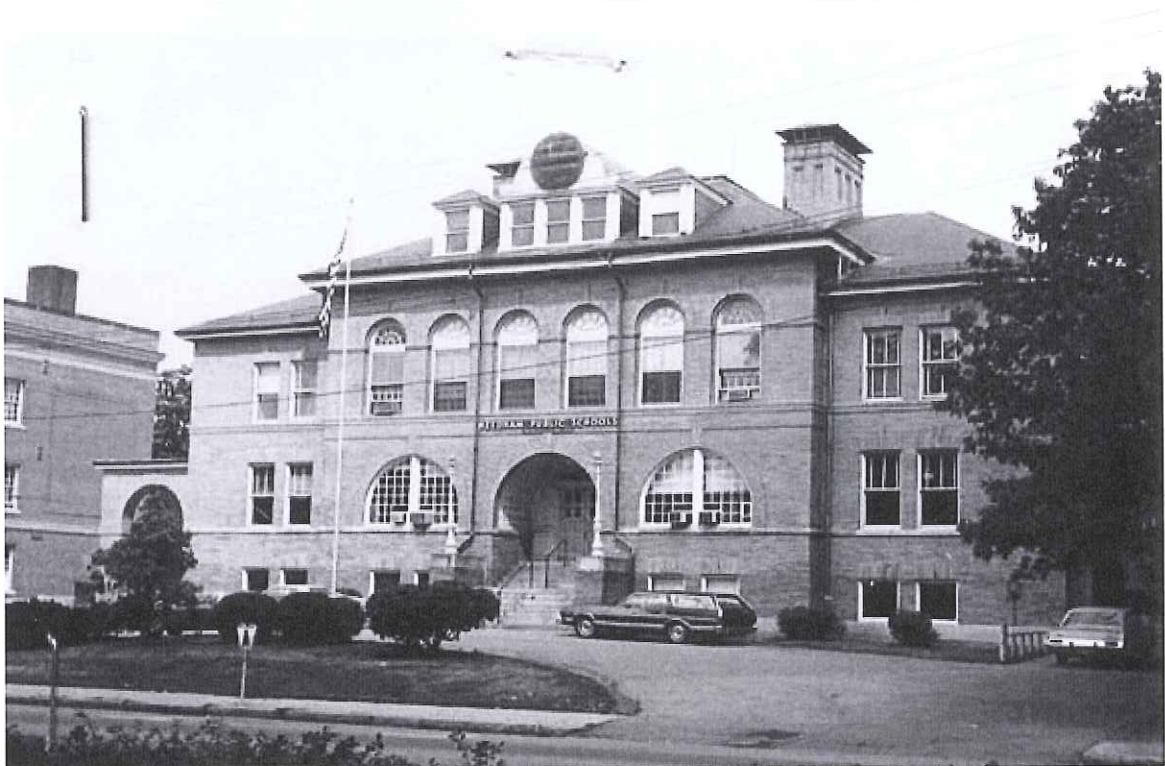
The original post lamps were present as recently as 1980.

Lighting: The original post lamps at the front entry have been removed. Currently the only exterior lighting is a flood light at the front entry ceiling, lighting the landing area. As this entry location might be filled in, the need for exterior lighting here would go away. There will need to be site lighting and building lighting at entries.

1. Provide site lighting for all pedestrian areas and building lighting at all entries. All lighting is to be of a style that is appropriate for the design of this building. Assume a high quality manufacturer, though not custom fixtures.
2. Remove railings at south portico and provide painted steel railings with lamb's tongues similar to the other exterior railings but also compliant with current codes.
3. Infill grade and repave north elevation door location to accommodate what is assumed to be a return to a window at this location. This will be part of a larger grading issue relating to the accessible entry and the remainder of parking and landscape issues.

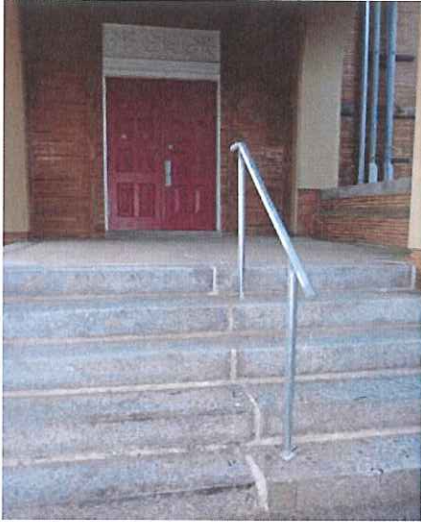
Railings: Painted steel railings at the main entry and north portico are in good condition, though extensions do not comply with ADA requirements. The railings at the south portico, while not in poor condition, are a galvanized metal and do not match the profile of the other railings.

The handrail at the south portico is not very sympathetic to the building.

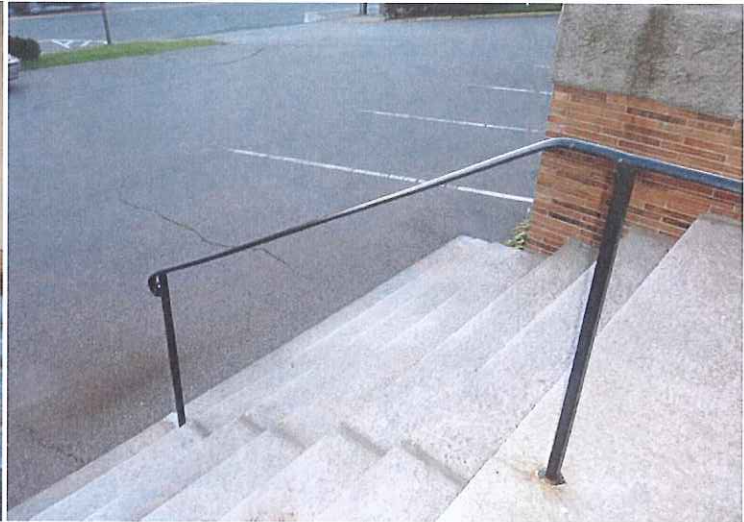
Handrails at the main and north entries are more successful, yet not compliant with ADA.

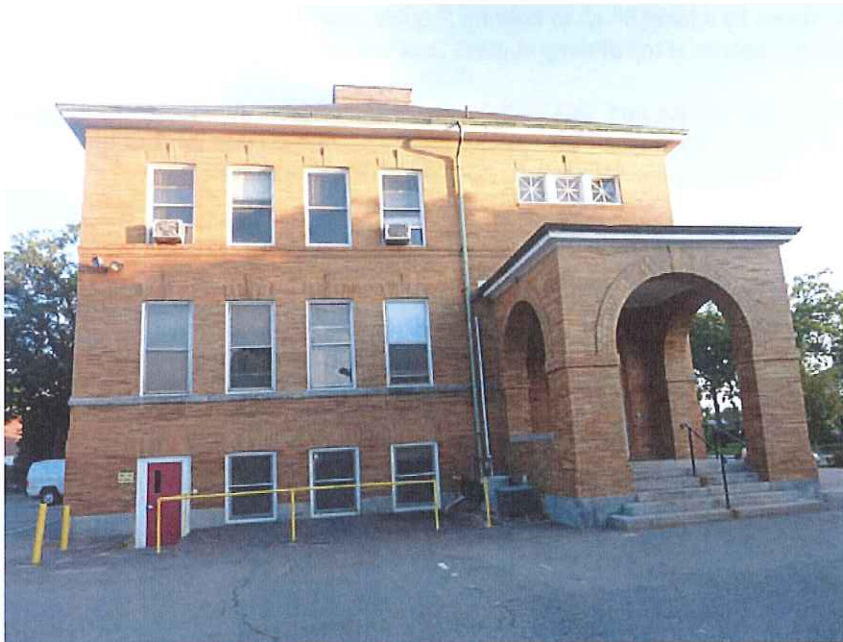
The north portico is the obvious location for an added ramp.

1. Provide glass enclosure at each of the three arched openings to create an entry vestibule. Include a high quality, low profile aluminum frame system and tempered, insulated glass.
2. Remove concrete finish at landing and provide recessed walk-off mat system.
3. Remove raised granite threshold at doors by cutting down to $\frac{3}{4}$ " above vestibule floor. Modify existing wood doors by adding 5" +/- to bottom. Provide new hardware at door, including automatic opener. (Automatic opener at top of ramp at glass door as well.)
4. Provide granite ramp surface and side walls/curbs at ramp/stairs. All railings to include laser-cut steel design at pickets. Include ice-melt system under new ramp/stairs. Brick at the east wall of the portico that is removed for the new openings is to be salvaged for reuse.

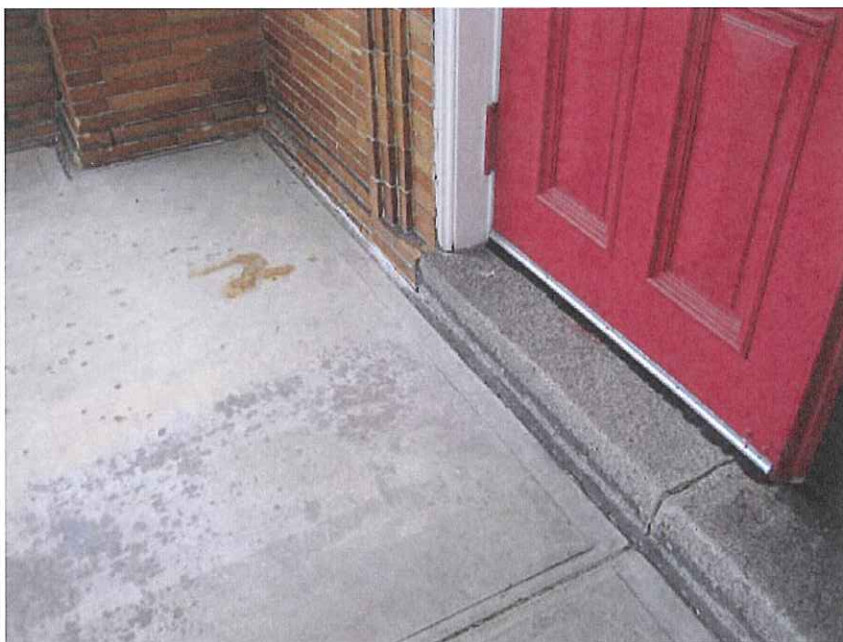
A step at the door location complicates the accessibility issue.

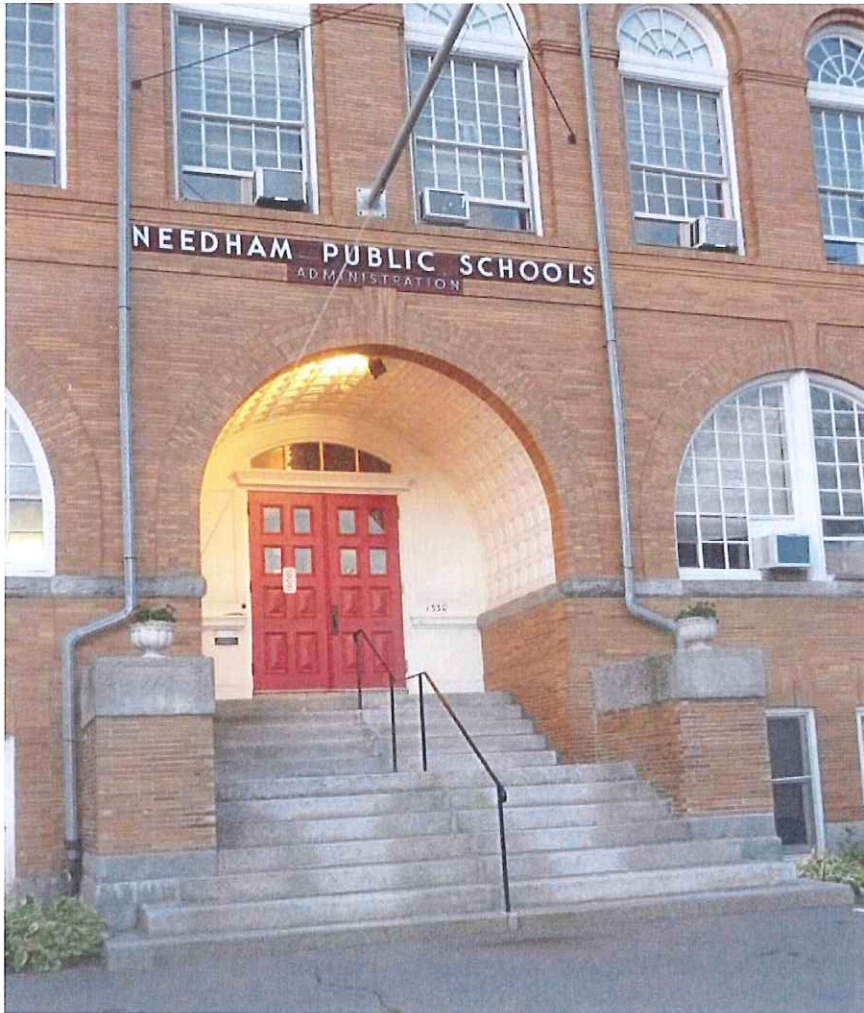
Making the existing front entry accessible to the disabled is not feasible, given the eight foot high rise to the landing. The ramp would be long and visually intrusive.

1. Provide dense stainless steel grating at level of first floor, supported on stainless steel structure set on existing granite steps.
2. Provide footings and a painted metal-clad low wall that is as high as the existing side walls of the stairs.
3. Provide a guard rail on top of the low wall, to 42" above the floor level.
4. Provide a new light fixture.

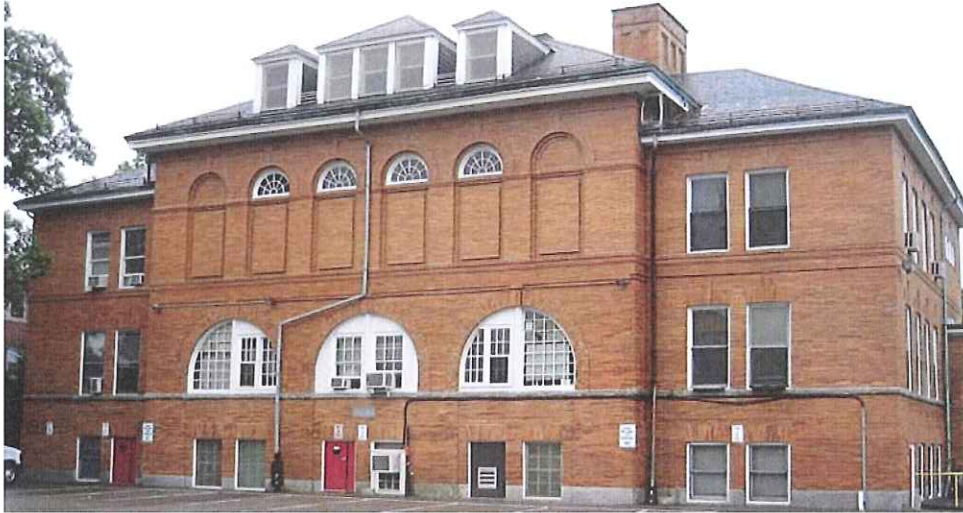
The brick infill at six 2nd floor windows would be removed and windows added.

1. At the four center windows remove and salvage the face brick. Remove the remaining back-up wall. Provide new wood windows similar to the other windows in the building.
2. Salvaged brick can be used at other locations on the building or stored for future use.

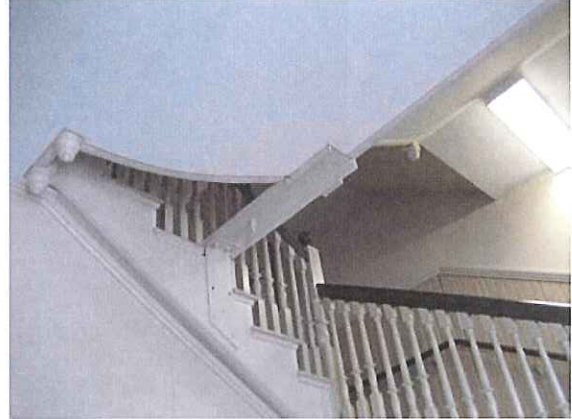
Stair structure has been reinforced with added steel at several locations.
